# APPENDIX 4

## DESCHUTES RIVER HABITAT INVENTORY SUMMARY REPORT, FEBRUARY 2020

# 2017 Deschutes River Habitat Inventory

## Final Summary Report

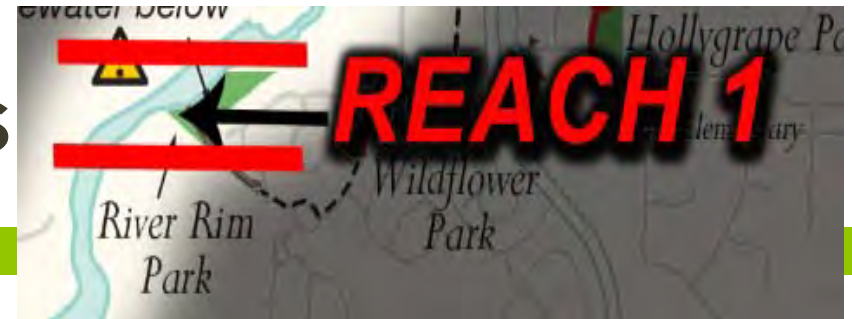
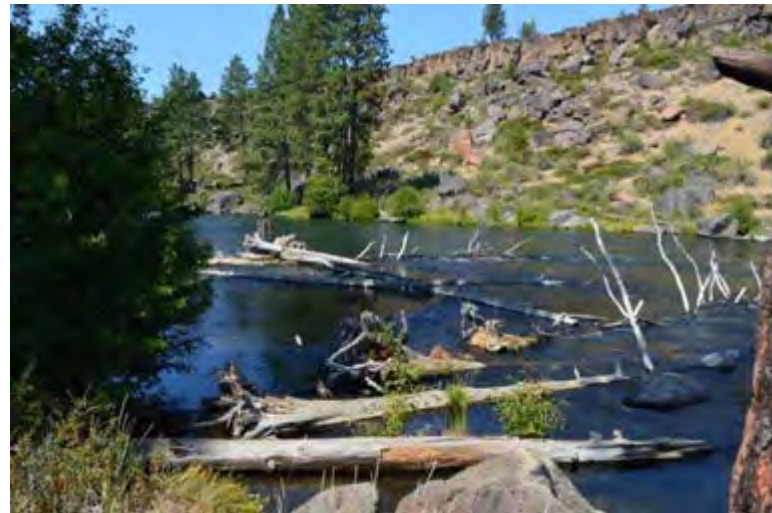
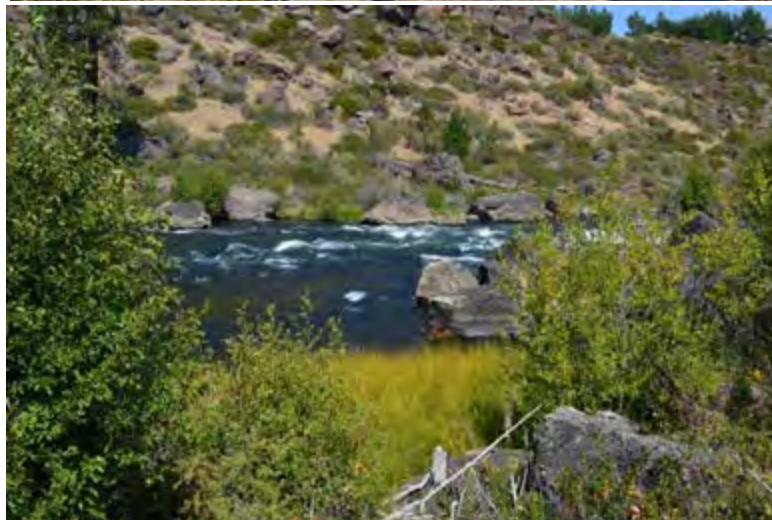
# Reach 1 Conditions

- **Channel condition.** In-water habitat includes rocks and large woody debris.
- **Bank condition.** Wetlands are present in this reach. Erosion is moderate, bank stability is bad, soil is somewhat compacted.
- **Riparian area.** Riparian vegetation covers 50% of viable area.
- **Upland area.** Upland vegetation covers 25% of viable area.
- **Access.** Manmade structures include an irrigation pump. There are nine access points in the reach. The reach is used as a put in for kayakers.

River Rim Park

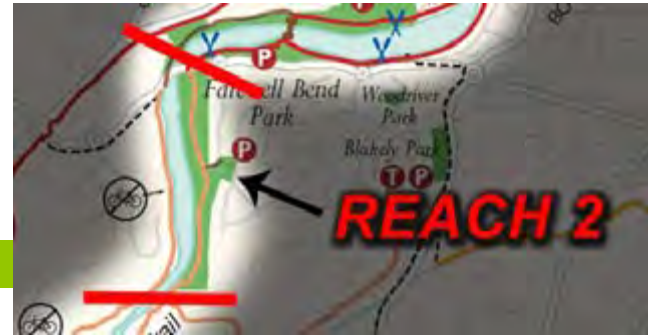
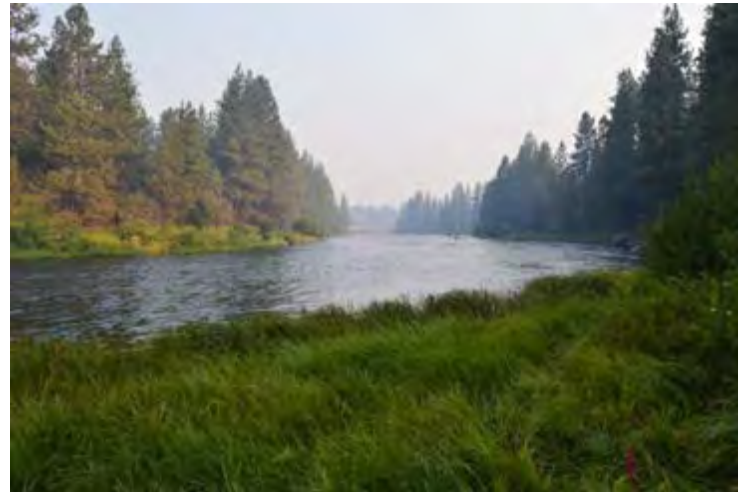
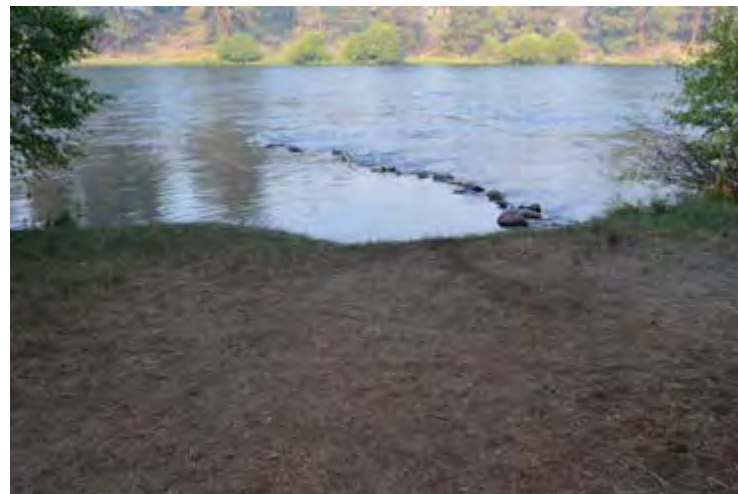
# Reach 2 Conditions

- **Channel condition.** Presence of beaver activity and damming in the reach.
- **Bank condition.** Wetlands are present in much of the reach. Erosion ranges from minimal to moderate in the reach. Bank stability is good throughout the reach. Soil is somewhat compact in most of the reach, with one segment being very compact.
- **Riparian area.** When compared with other reaches this reach has a large abundance of horsetail in the riparian zone. Riparian vegetation covers 70% to 85% of viable area for most segments, however, one segment has 0% coverage, and one has 50% coverage.
- **Upland area.** Upland vegetation covers between 60% and 100% of viable area for this reach.
- **Access.** Manmade structures include boardwalk upstream of reach and Bill Healy bridge. The reach has 36 access points.

Deschutes River Trail

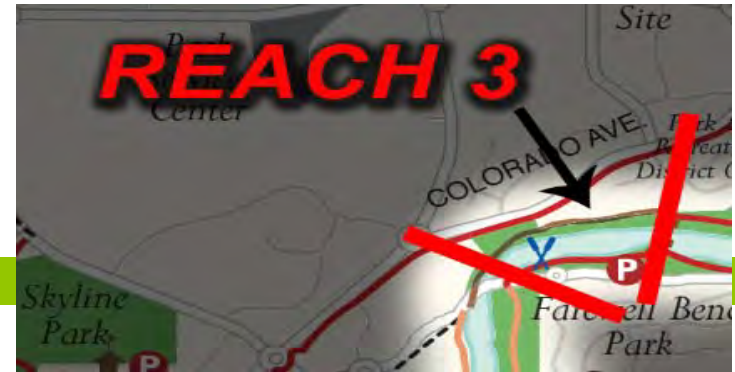
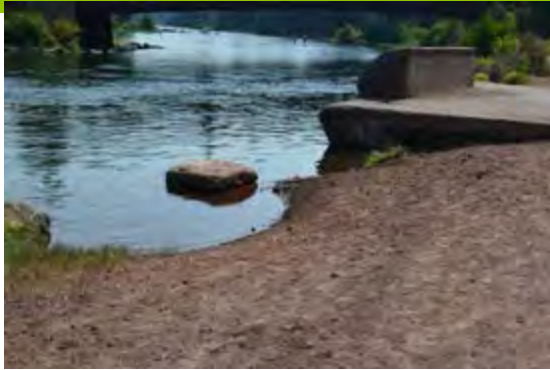
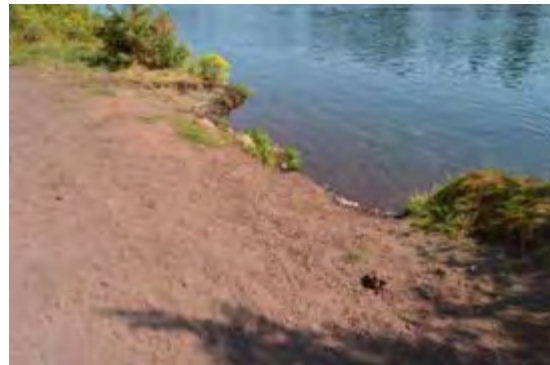
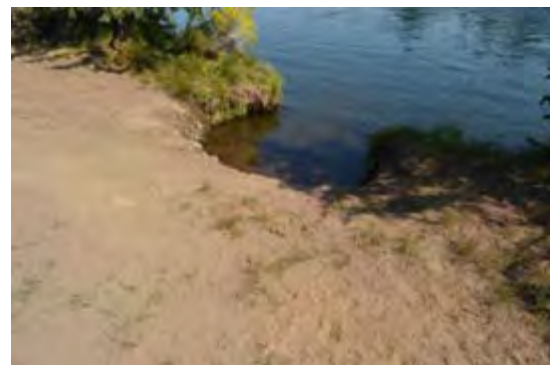
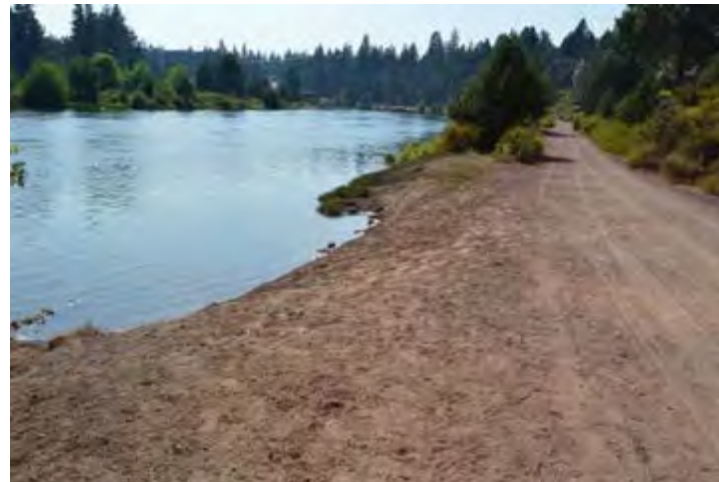
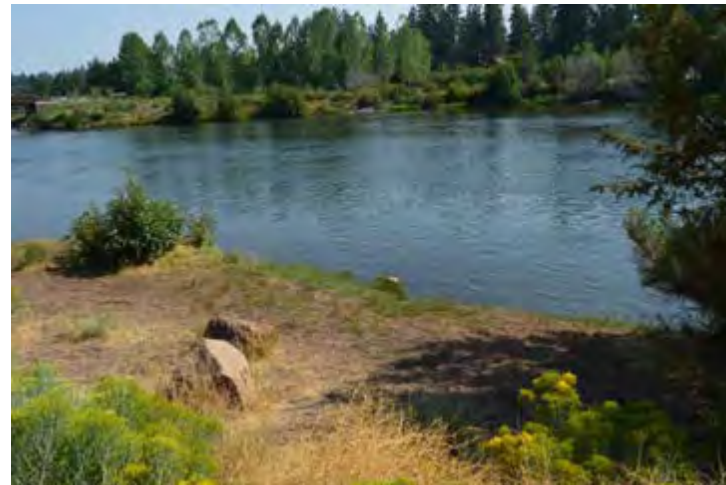
# Reach 3 RL Conditions

- **Channel condition.** River flows in this reach are categorized as slack water. In water habitat includes rocks, wetlands, large woody debris (LWD), and undercut banks.
- **Bank condition.** Wetlands are present in two of three segments. Erosion ranges from moderate to severe. Bank stability is bad throughout. Soil is somewhat compact for all segments.

River Bend Park

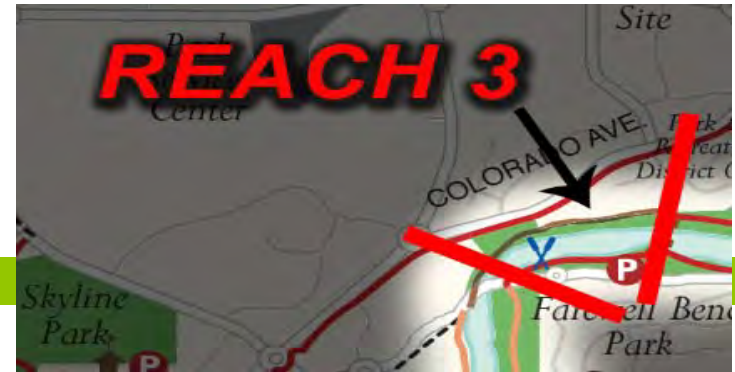
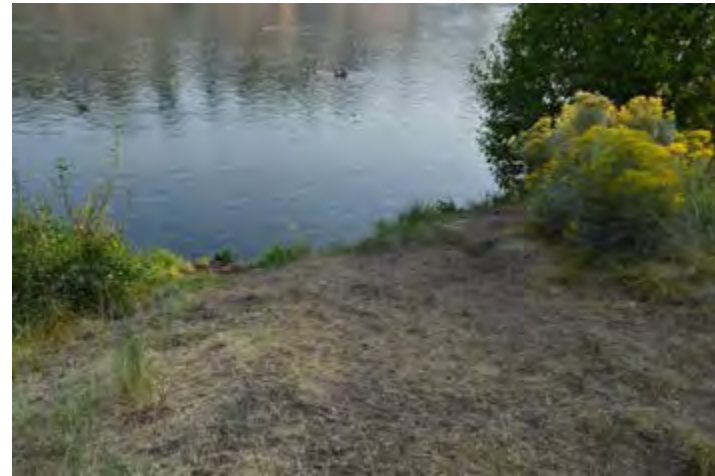
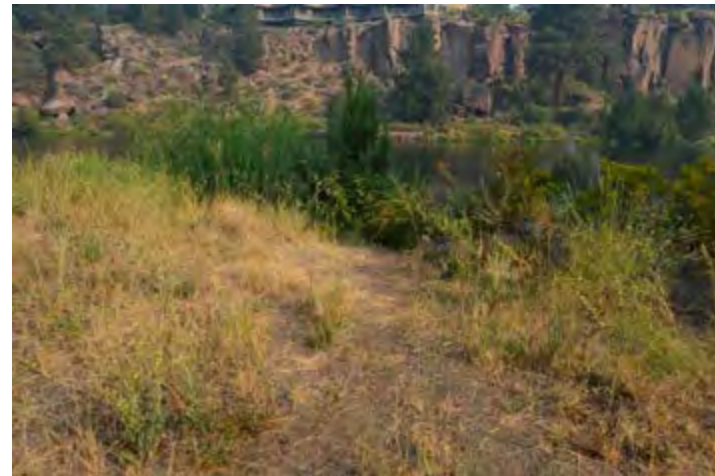
# Reach 3 RR Conditions

- **Channel condition.** Channel conditions are similar to river left conditions, LWD does not exist on river right.
- **Bank condition.** Wetlands are present in all three segments. Erosion ranges from moderate to severe. Bank stability is bad throughout. Soil is very compact in two sections and somewhat compact in one section.
- **Riparian area.** Riparian vegetation covers 0% to 40% of viable area.
- **Upland area.** Upland vegetation coverage data was not collected.
- **Access.** The reach has 14 access points. The area with single rail fencing has many access points, where double rail fencing exists, the number of access points is greatly reduced.

Farewell Bend Park

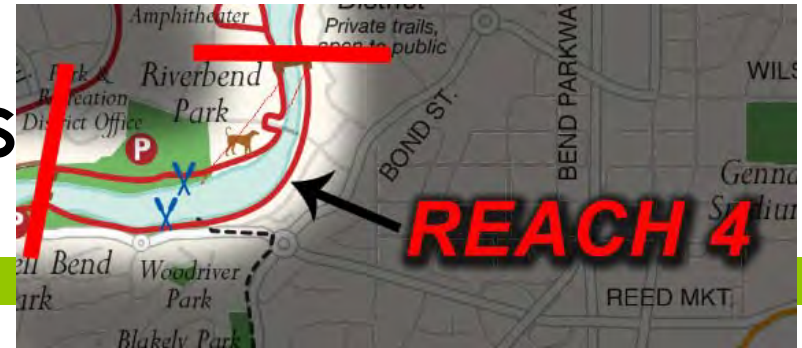
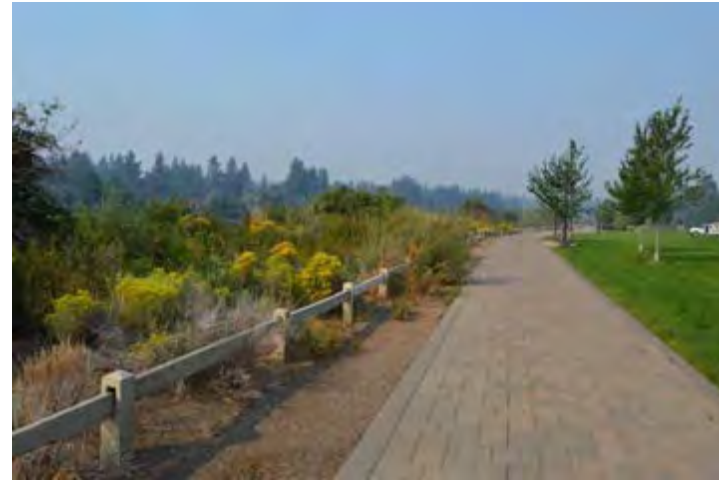
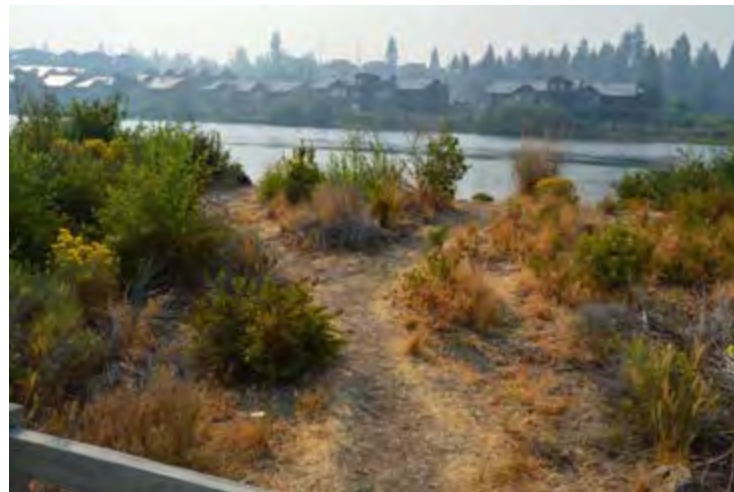
# Reach 4 RL Conditions

- **Channel condition.** River flows in this reach are categorized as slack water. In water habitat includes rocks, wetlands, and undercut banks.
- **Bank condition.** Wetlands are present in two of three segments. Erosion ranges from minimal to moderate. Bank stability is good in two segments and bad in one. Soil is loose for all segments.
- **Riparian area.** Riparian vegetation covers 65%, 10%, and 0% of viable area for segments 1, 2, and 3, respectively.
- **Upland area.** Upland vegetation coverage data was not collected.
- **Access.** River left has 17 access points. Sections with double rail fencing have few access points, the section with single rail fencing has many access points given its length (5 access points in 475 feet).

Riverbend Park

- Transition single rail to double rail fencing
- Replace interpretive signage
- Armor access point where concrete abutment is
- Evaluate "mudflat" for possible wetland revegetation

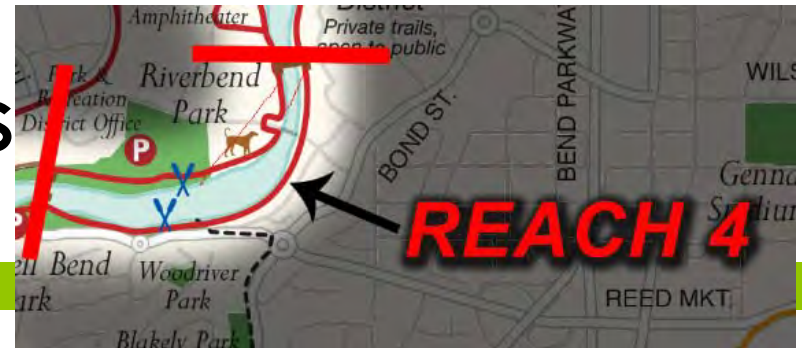
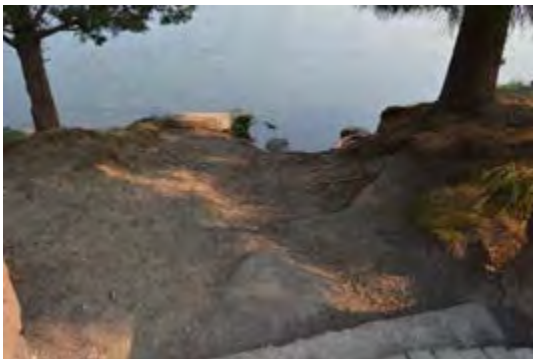
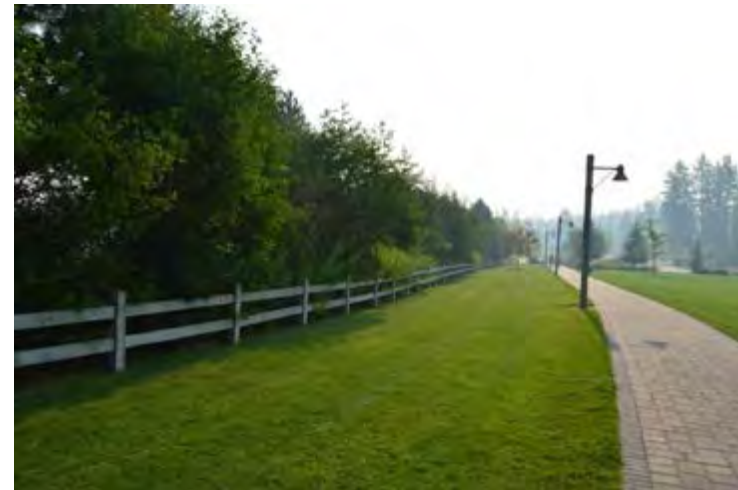
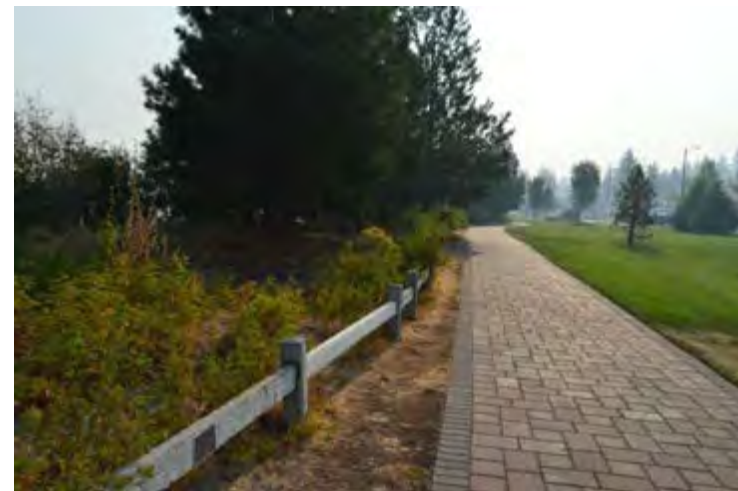
# Reach 4 RR Conditions

- **Channel condition.** River flows in this reach are categorized as slack water. In water habitat includes rocks, wetlands, and LWD.
- **Bank condition.** Wetlands are present in both segments. Erosion is minimal. Bank stability is good throughout. Soil is somewhat compact.
- **Riparian area.** Riparian vegetation covers 25% to 50% of viable area.
- **Upland area.** Upland vegetation coverage data was not collected.
- **Access.** The reach has seven access points, with six falling within the area with single rail fencing.

Farewell Bend Park

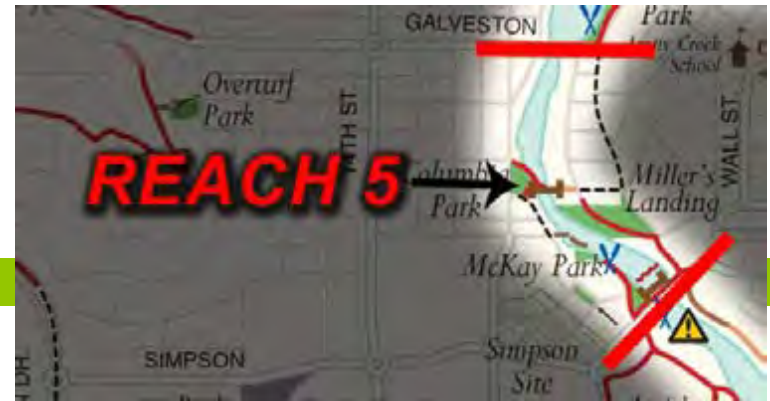
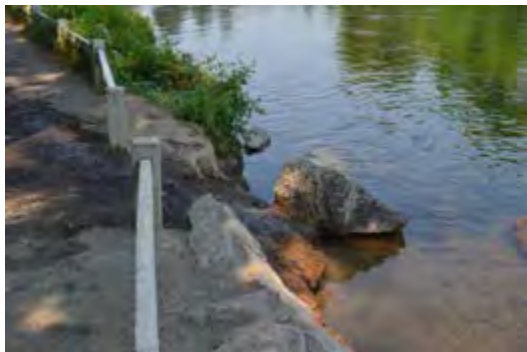
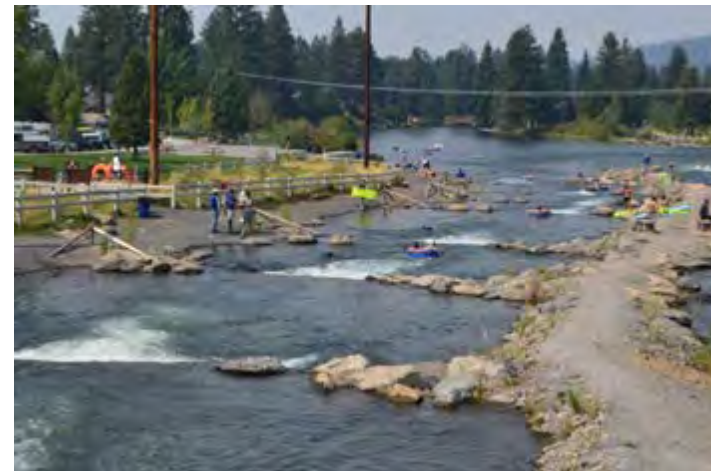
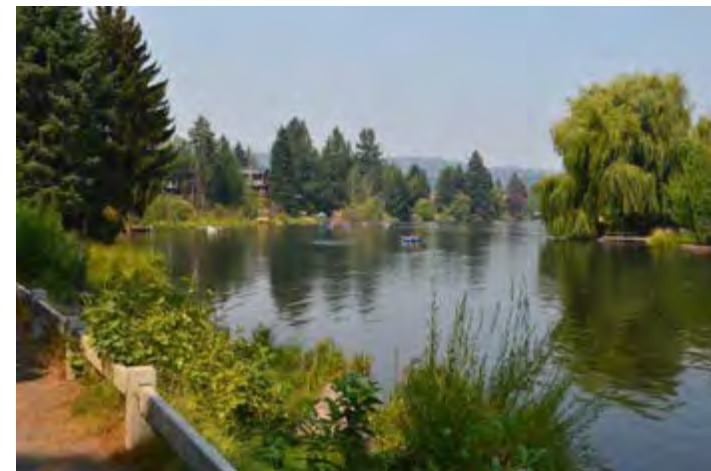
# Reach 5 RL Conditions

- **Channel condition.** The channel is slack water in this section. In water habitat includes rocks, wetlands, and LWD.
- **Bank condition.** Wetlands are present in one segment. Erosion is moderate. Bank stability is good in two sections and bad in one section. Soil is loose and somewhat compact.
- **Riparian area.** Riparian vegetation covers 5% to 35% of viable area.
- **Upland area.** Upland vegetation coverage data was not collected.
- **Access.** The park has five access points.

Whitewater Park/Columbia Park

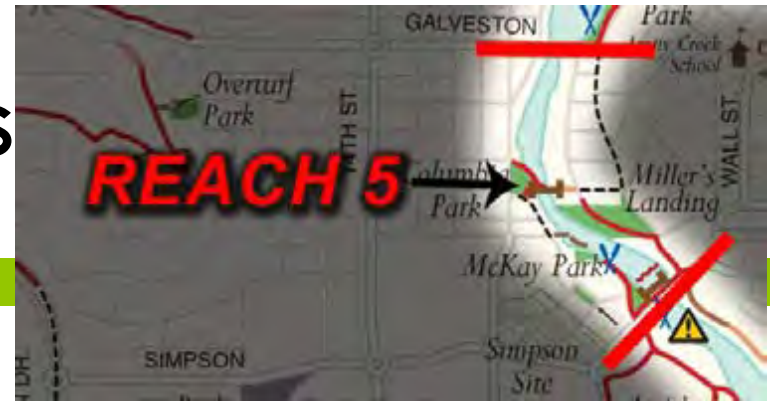
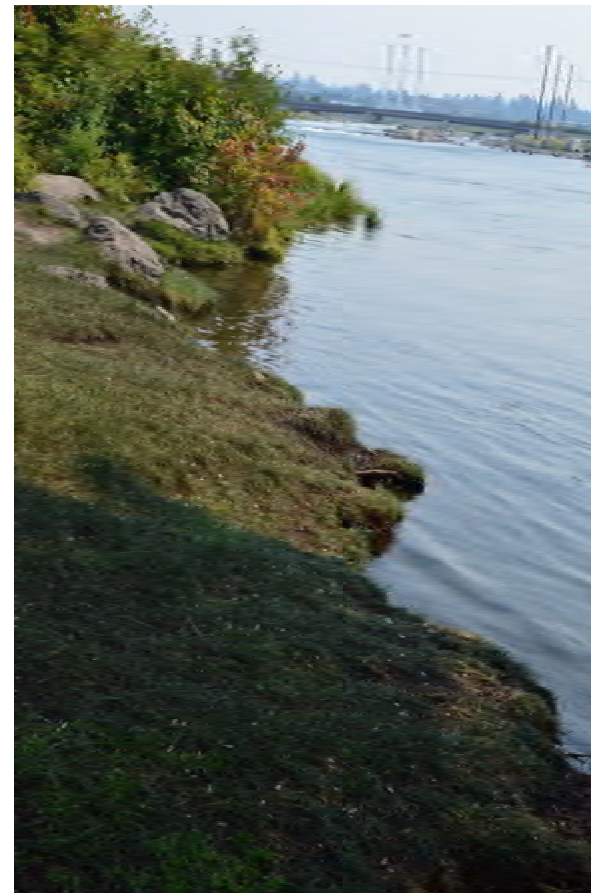
# Reach 5 RR Conditions

- **Channel condition.** The channel is slack water in this section. In water habitat includes rocks, wetlands, LWD, and undercut bank.
- **Bank condition.** Wetlands are present in two segments. Erosion is minimal in two sections and severe in one section. Bank stability is good in two sections and severe in one section. Soil is loose and somewhat compact.
- **Riparian area.** Riparian vegetation covers 0% to 75% of viable area.
- **Upland area.** Upland vegetation coverage data was not collected.
- **Access.** The park has two access points.

Millers Landing

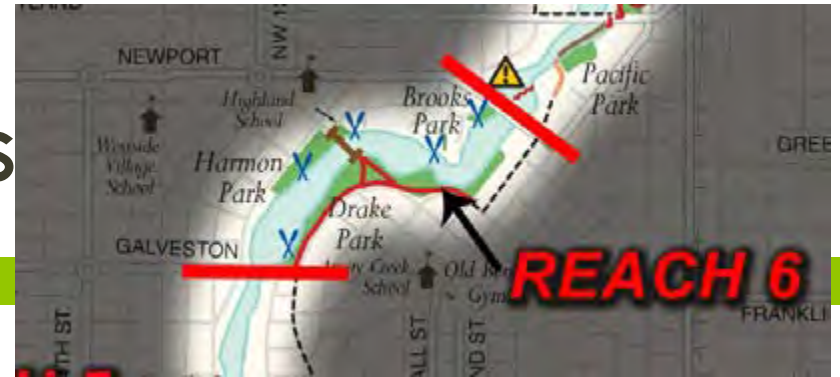
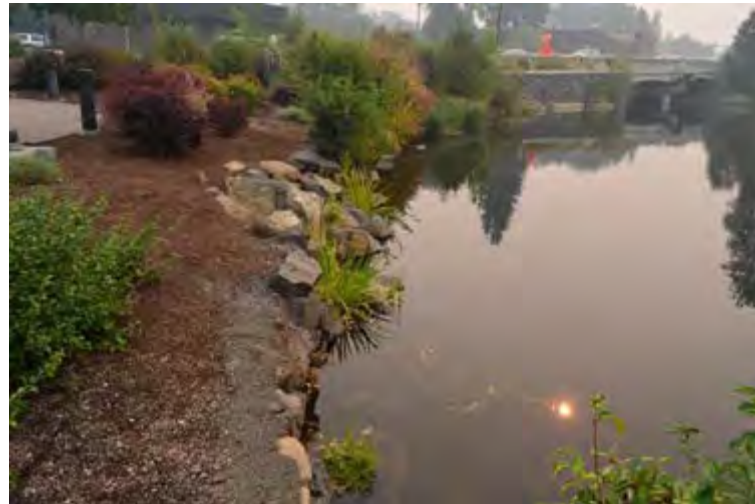
# Reach 6 RL Conditions

- **Channel condition.** Channel type is slack water. In water habitat includes rocks, wetlands, LWD and undercut bank.
- **Bank condition.** Wetlands are present. Erosion ranges from minimal to moderate. Bank stability is good to bad. Soil is somewhat compact. Seawall forms the bank for one segment.
- **Riparian area.** Riparian vegetation covers 0% to 65% of viable area.
- **Upland area.** Upland vegetation coverage is 0% of viable.
- **Access.** There are six access points.

- **Channel condition.** The channel is slack water in this section. In water habitat includes rocks.
- **Bank condition.** Wetlands are present. Erosion is moderate. Bank stability is bad. Soil is somewhat compact. Seawall is present along the park.
- **Riparian area.** Riparian vegetation covers 10% of the viable area.
- **Upland area.** Upland vegetation coverage is 0%.
- **Access.** Access exists for the entire park.

- In- water revegetation
- Remove seawall and lay back banks
- Fencing to minimize habitat degradation

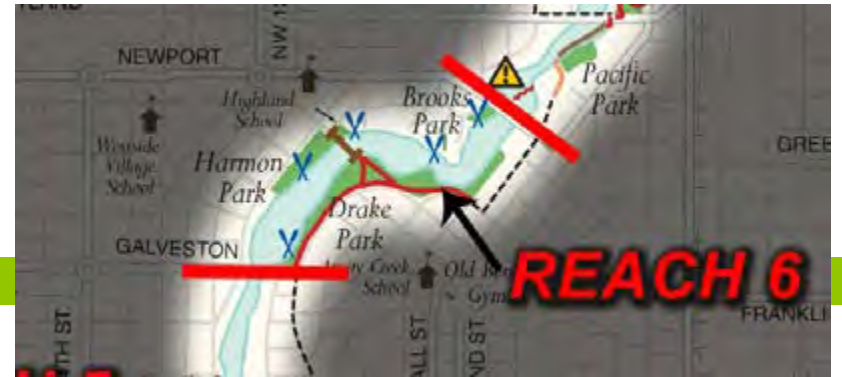
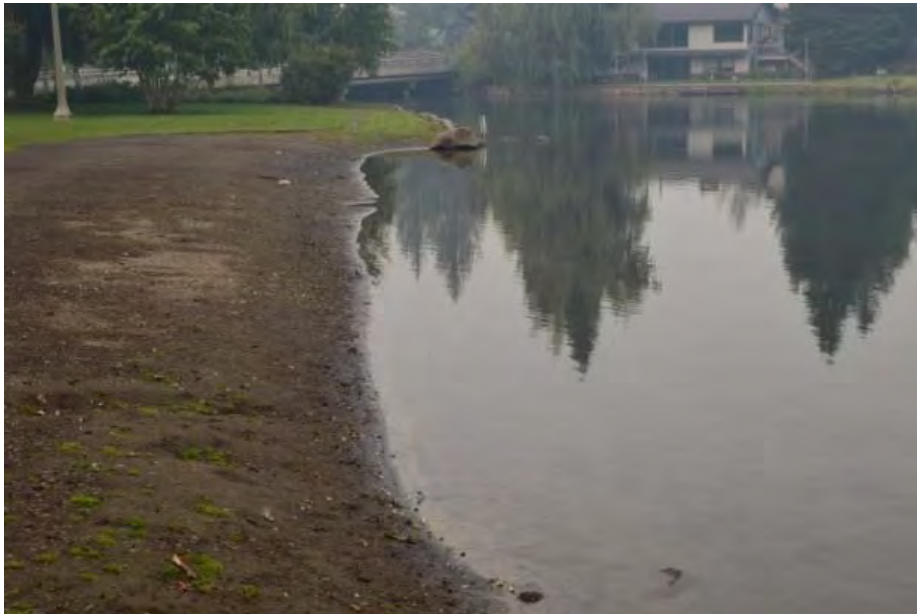
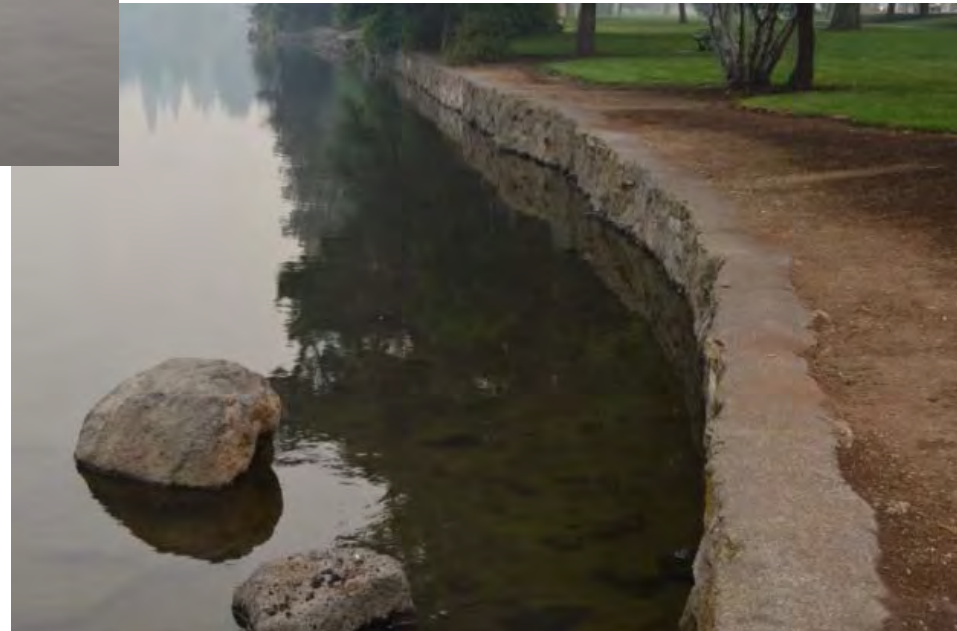
# Reach 6 RR Conditions

- **Channel condition.** The channel is slack water in this section. In water habitat includes rocks, wetlands, LWD, and undercut bank. One segment has presence of LWD overhanging trees and three small islands in the middle of the river.
- **Bank condition.** Wetlands are present in one segment. Erosion is moderate to severe. Bank stability is bad to severe. Soil is somewhat compact. Seawall is present in all three sections.
- **Riparian area.** Riparian vegetation covers 0% to 10% of viable area.
- **Upland area.** Upland vegetation coverage is 0%.
- **Access.** Access exists for the entirety of two sections. In the third section, five access points exist.

Drake Park

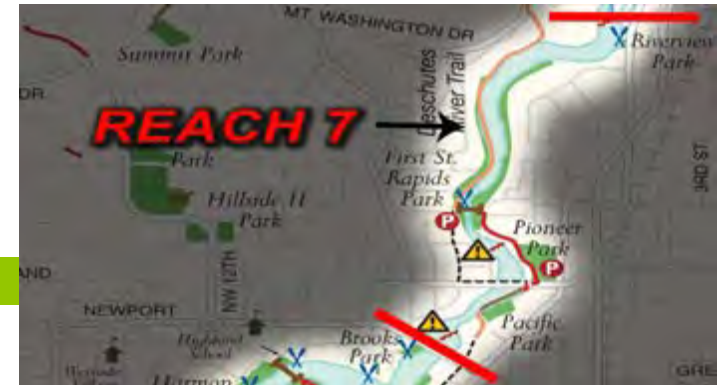
# Reach 7 Conditions

- **Channel condition.** Channel type is riffle. In water habitat includes rocks.
- **Bank condition.** Wetlands are not present. Erosion is minimal. Bank stability is bad. Soil is somewhat compact. Seawall is present along the entire bank.
- **Riparian area.** Riparian vegetation covers 0% of the viable area.
- **Upland area.** Upland vegetation coverage data was not collected.
- **Access.** River access exists for the entire park.

Pioneer Park

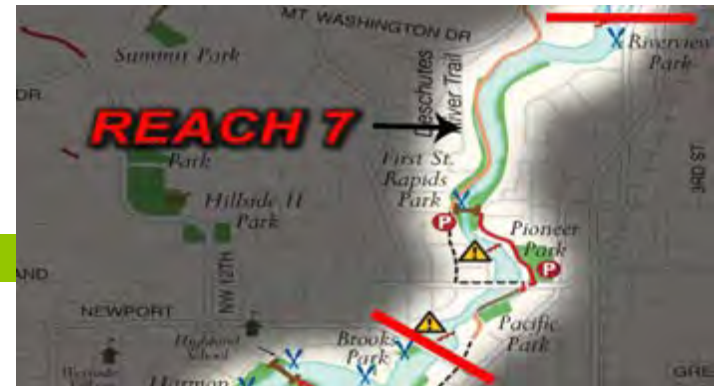
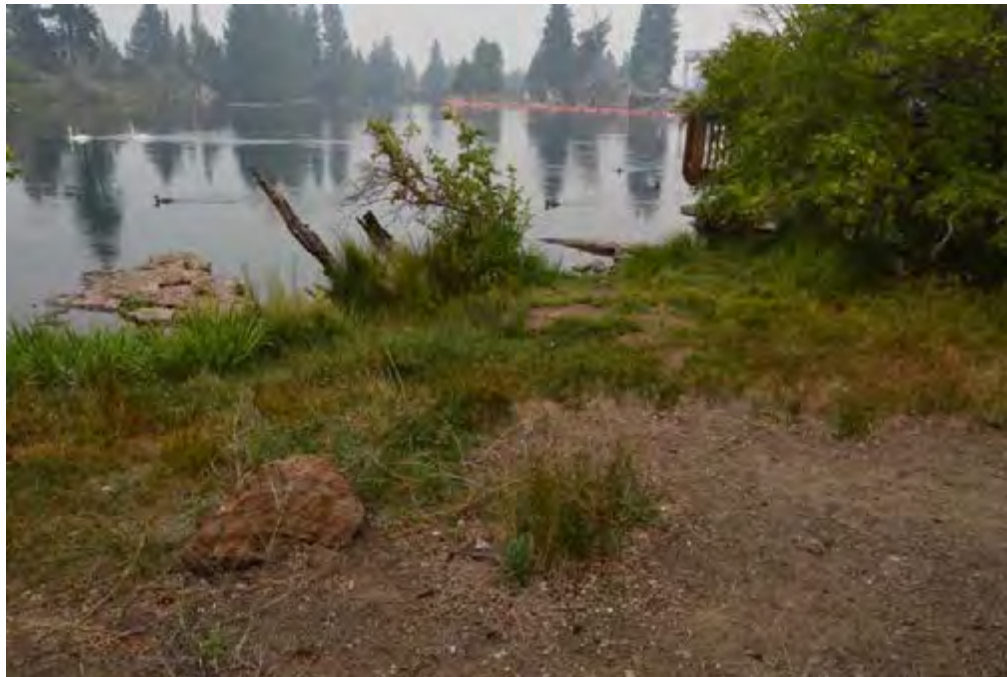
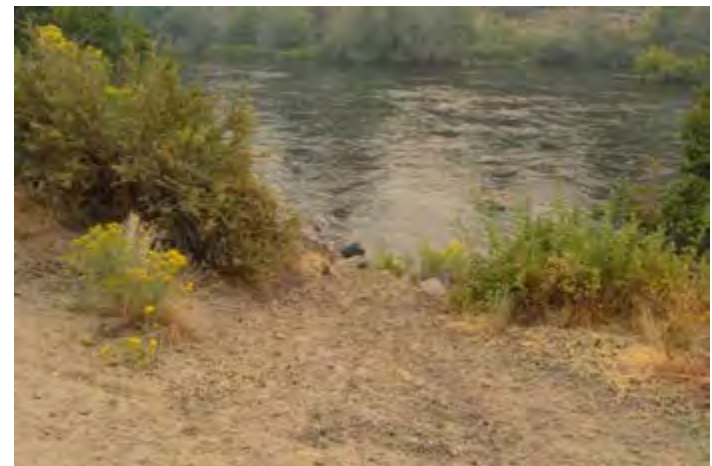
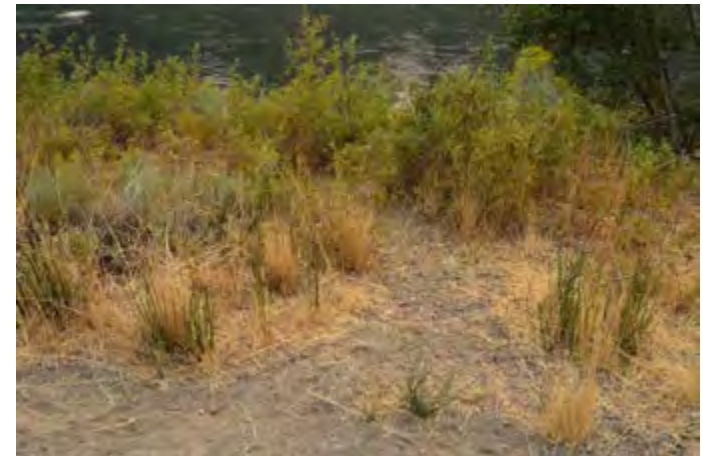
# Reach 7 RL Conditions

- **Channel condition.** The channel has rapids, a run, and slow water in this section. In water habitat includes rocks, wetlands, LWD, and undercut bank.
- **Bank condition.** Wetlands are present. Erosion is minimal to severe. Bank stability is good to bad. Soil is somewhat compact and very compact in sections.
- **Riparian area.** Riparian vegetation covers 5% of viable area in two sections, 10% of viable area in two sections, and 75% of viable in one section.
- **Upland area.** Upland vegetation coverage data was not collected.
- **Access.** First Street Rapids Park has 45 access points. A small section of double rail fencing is ineffective along river left. Two segments, while having few access points, were highly impacted.

Deschutes River Trail- downstream of 1<sup>st</sup> St. rapids

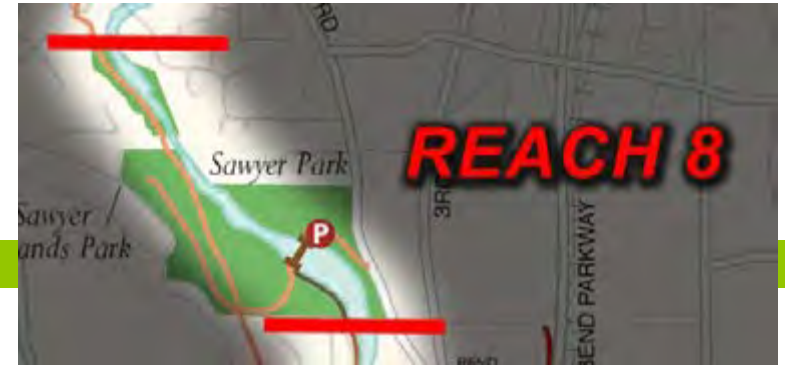
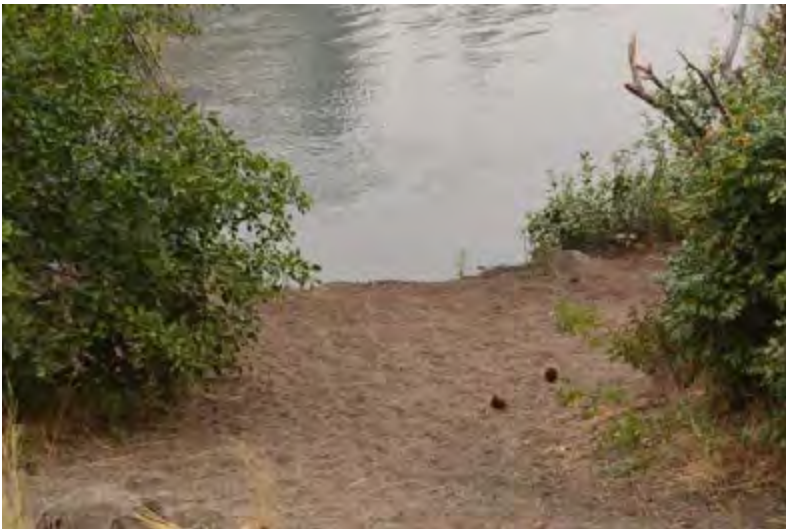
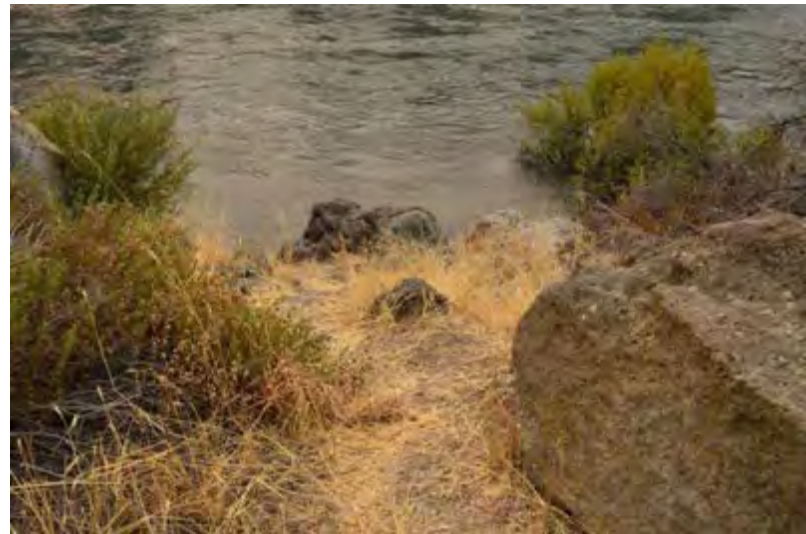
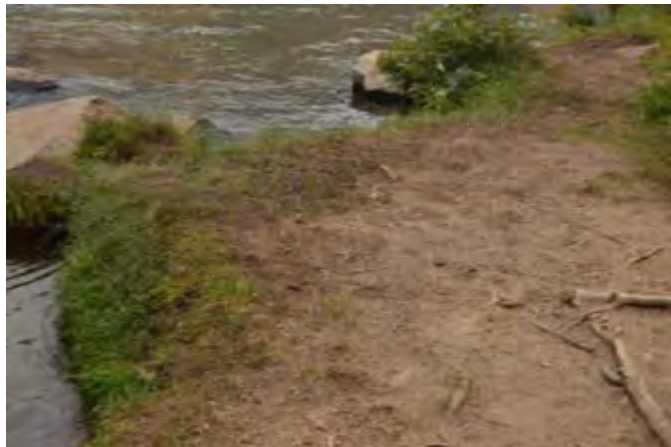
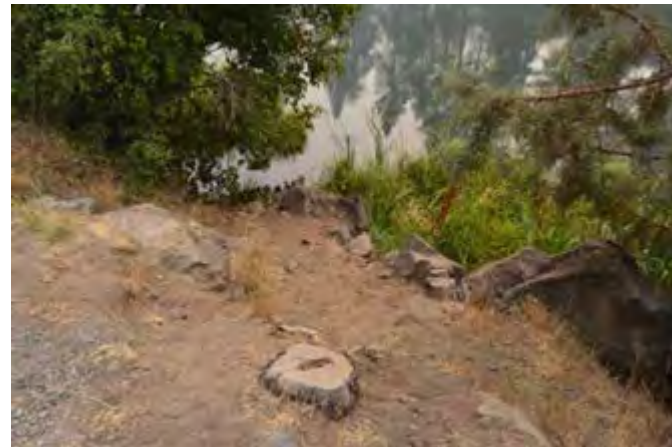
# Reach 8 Conditions

- **Channel condition.** Channel types in this reach include rapids, riffles, runs and slow water. In-water habitat includes rocks, wetlands, large woody debris and undercut bank.
- **Bank condition.** Wetlands are present in every section. Erosion is minimal in five sections, moderate in four sections and severe in two sections. Bank stability is good in six sections and bad in five sections. Soil is loose in three sections, somewhat compact in three sections, and severe in five sections. River left below the footbridge is in very poor condition.
- **Riparian area.** Riparian vegetation coverage ranges from 30% to 100% of viable area.
- **Upland area.** Upland vegetation coverage was not measured for two sections, was 25% of viable area for two sections, and 100% of viable area for the remaining seven sections.
- **Access.** There are 45 access points in this reach.

Sawyer Park

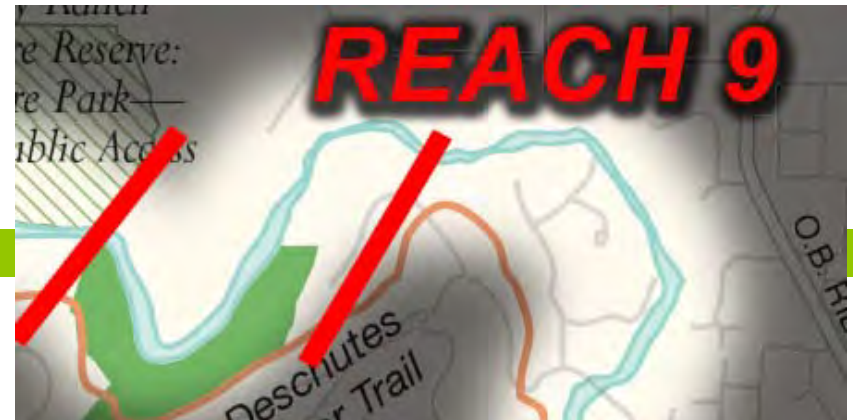
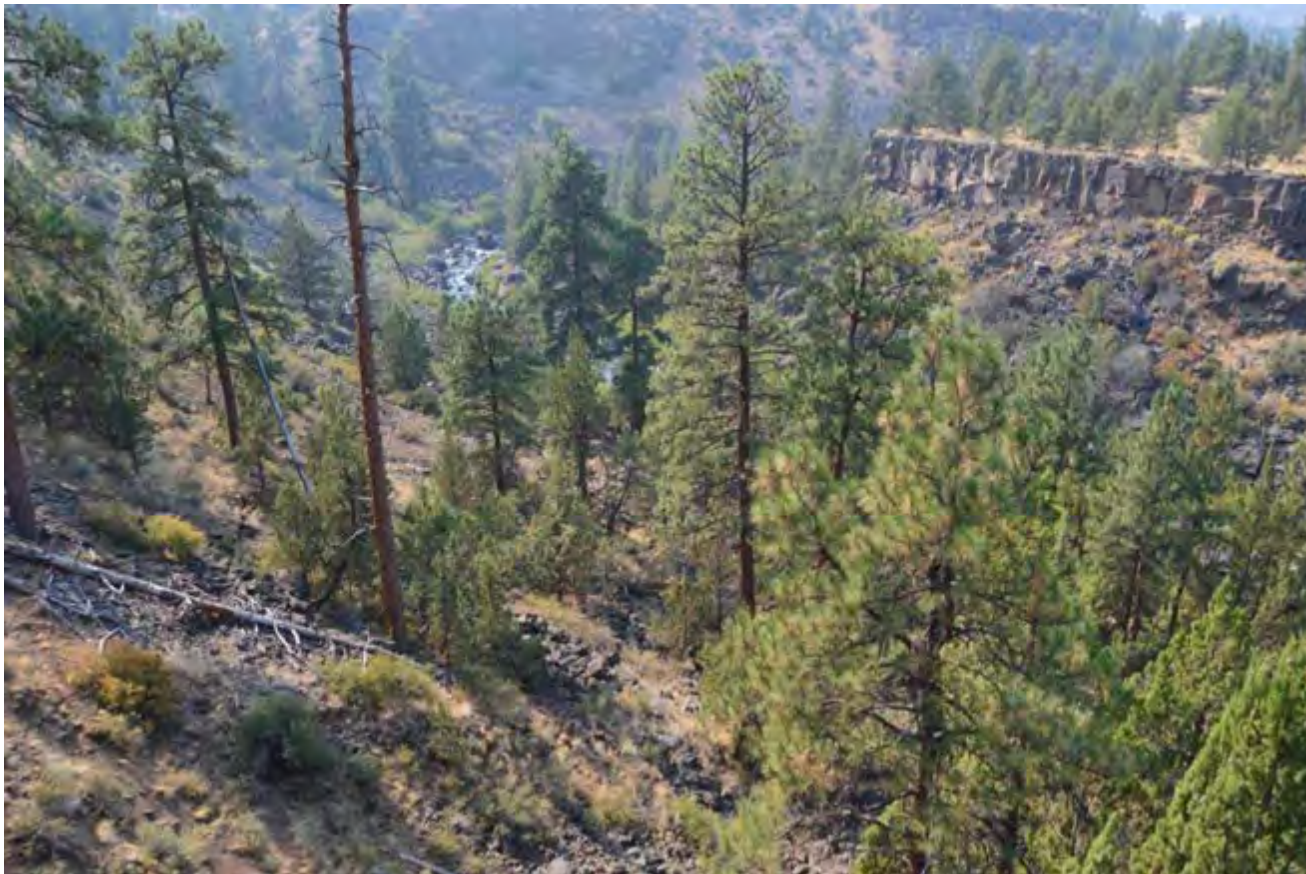
# Reach 9 Conditions

- **Channel condition.** Channel type includes rapids and riffles. In-water habitat includes rocks, wetlands and large woody debris.
- **Bank condition.** Wetlands are present in this reach. Erosion is minimal, bank stability is good, soil is somewhat compacted in one section, and very compacted in the remaining five sections.
- **Riparian area.** Riparian vegetation covers 20% to 35% of viable area.
- **Upland area.** Upland vegetation covers 75% to 100% of viable area.
- **Access.** There are three access points in the reach.
